The Locomotive

THE HARTFORD STEAM BOILER INSPECTION AND INSURANCE CO.

VOL. XL

HARTFORD, CONN.
1934-1935

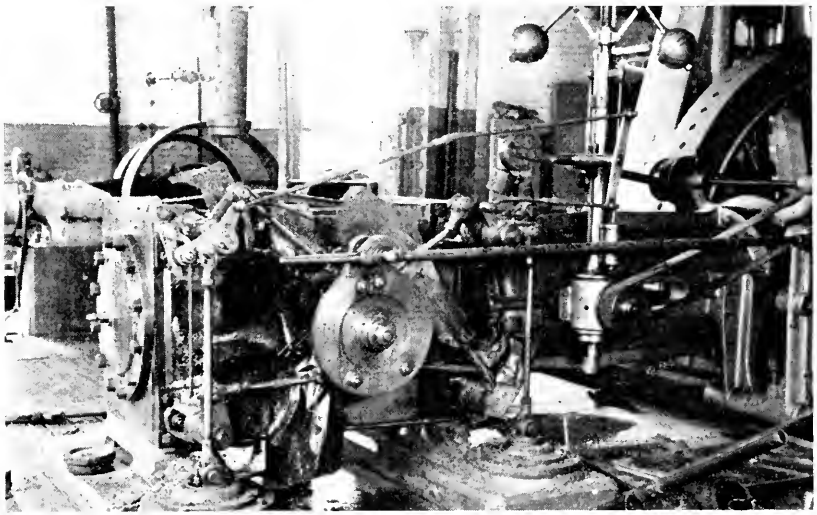
Steam end of compressor after the blowing out of the exhaust-steam cylinder-jacket.

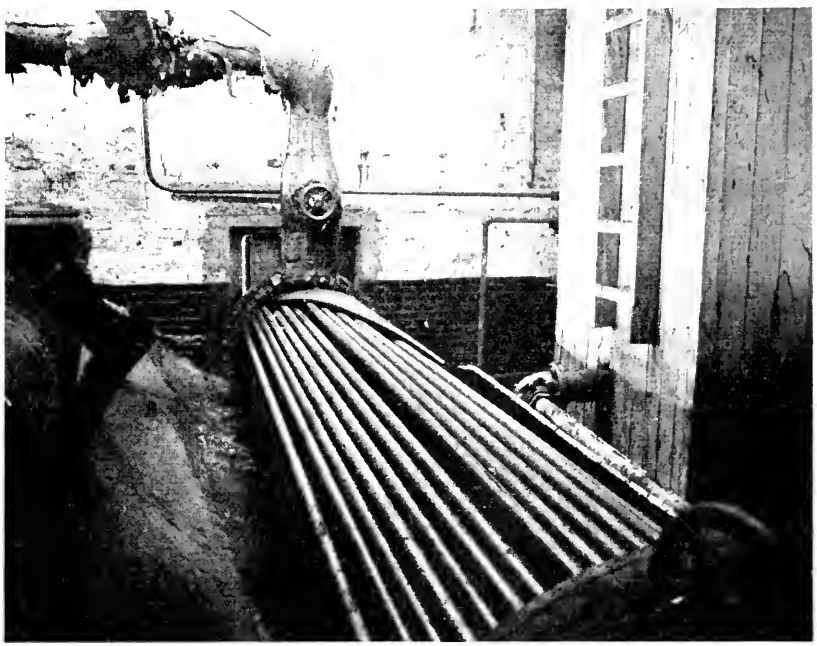
Figure 1—Caused by an unsound weld.

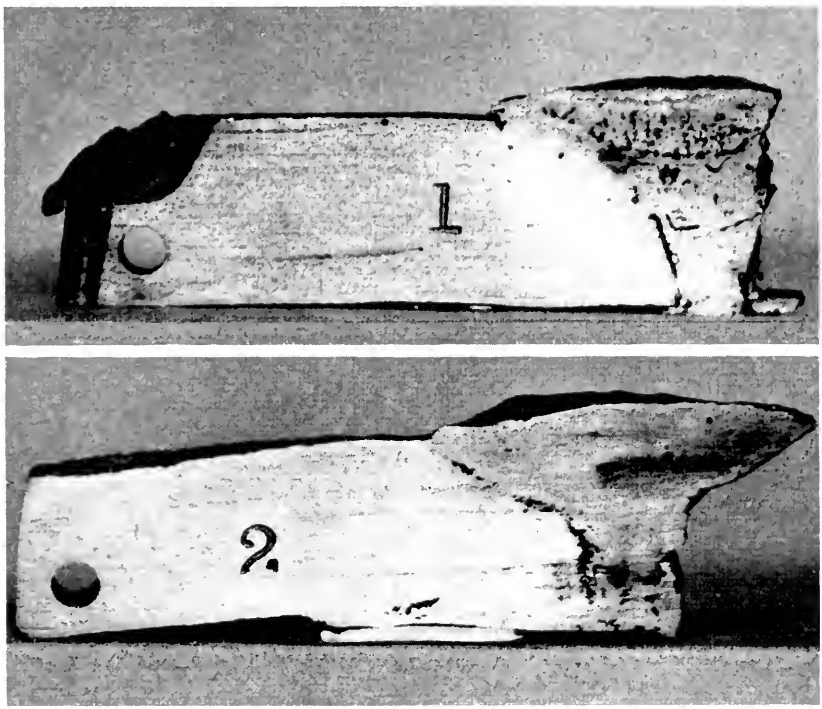
Figure 2—Etched specimens of the seams from the vessel shown in Figure 1.

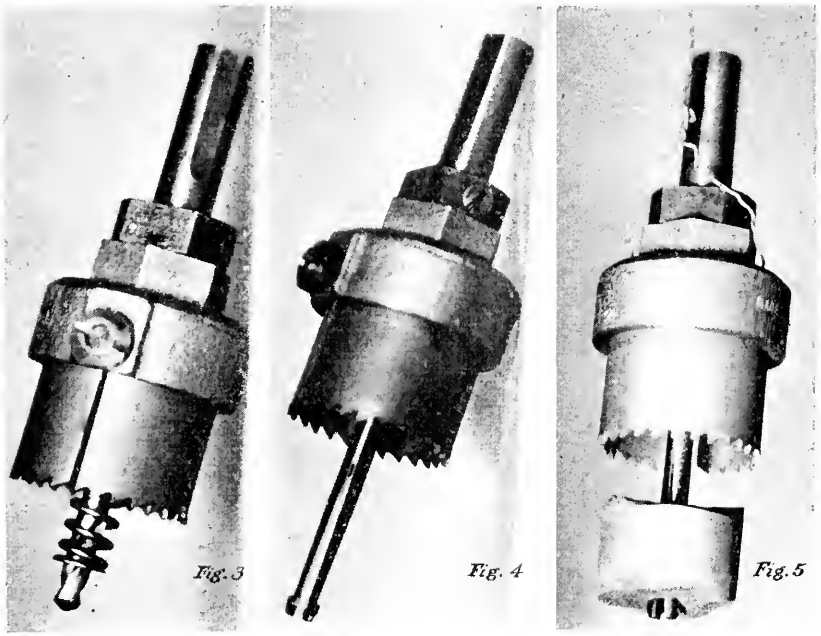
Figure 3—Tool used for trepanning a plug from a welded seam. Figure 4—Special spring and split pilot developed for trepanning tool. Figure 5—How the plug is withdrawn from the hole.

One of the problems that was encountered in using a tool of this kind was how to retain the plug after it had been cut through. The answer to this was the development of the special spring end split pilot or mandrel shown in Figure 4. With such a pilot the plug is held and is withdrawn from the vessel with the trepanning tool or hole saw as shown in Figure 5. The plug is then sectioned, polished, and deep etched in a boiling solution of equal parts of hydrochloric acid and water.

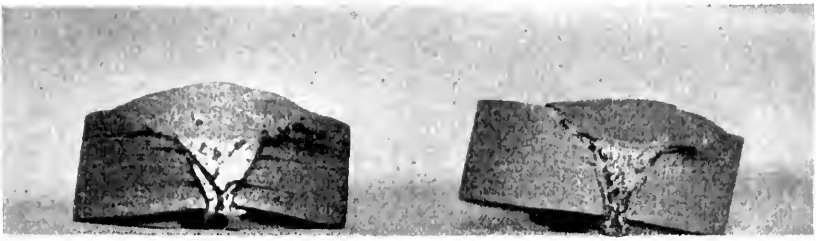
Fig. 6

Figure 6—Specimens from a fusion welded ammonia brine cooler.
Figure 7—Plugs cut from a fusion welded ammonia generator.
Figure 8—Plugs from a fusion welded soap kettle.

Some examples of plugs that have been cut from questionable vessels will be of interest. Figure 6 shows specimens removed from a fusion welded ammonia brine cooler which had been in service for several years. It is interesting to compare these plugs with the etched cross section of the weld shown in Figure 3. What might have happened if the vessel, from which the plugs were cut, had remained in service may readily be conjectured.

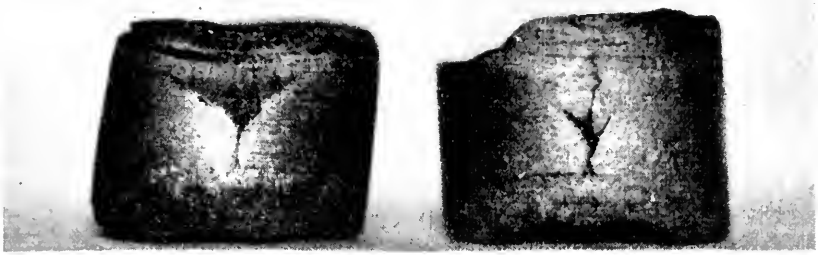
Fig. 7

Figure 7 shows plugs cut from a fusion welded ammonia generator in an absorption system. After seeing these plugs, the owner decided to replace the vessel.

Figure 8 shows specimens cut from a fusion welded soap kettle. The defective seam of this vessel was rewelded by a competent operator.

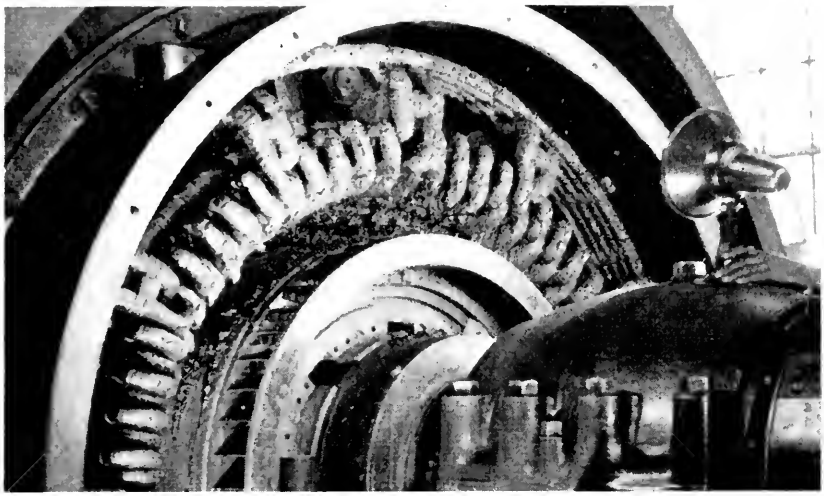
Collector ring end of the idle alternator after its electrical burnout.

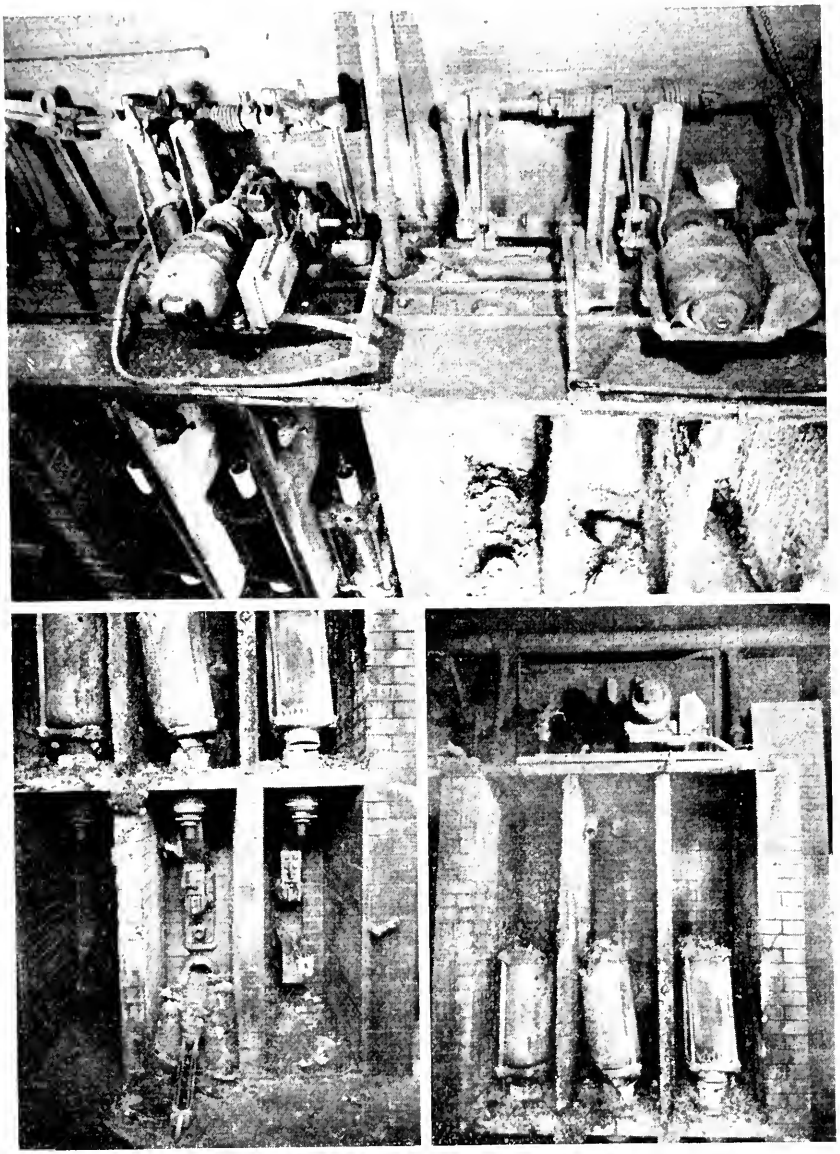
The heat induced in the idle generator under the circumstances would be mostly concentrated on the outside surface of the field core. In this

case the heat was so intense that, due to unequal expansion between the outside surfaces and the internal parts of the core, the steel forging was cracked. The accident necessitated an entirely new field. The damage to the stator winding was apparently caused by radiant heat from the core of the field, as the coils indicated that they had been exposed to a very high external temperature.

What started the series of events which led to this accident is still undetermined. The following is probably the correction sequence:

A terminal connection in the middle cell of the oil switch for the generator in operation heated and started little pin arcs. This trouble gradually grew until a sufficient arcing developed to vaporize some of the brass or copper. The arcing followed the vaporized metal and finally involved all three phases. The energy for the arc was supplied from the operating 10,000 kw alternator and the No. 1 Edison feeder. The arc-

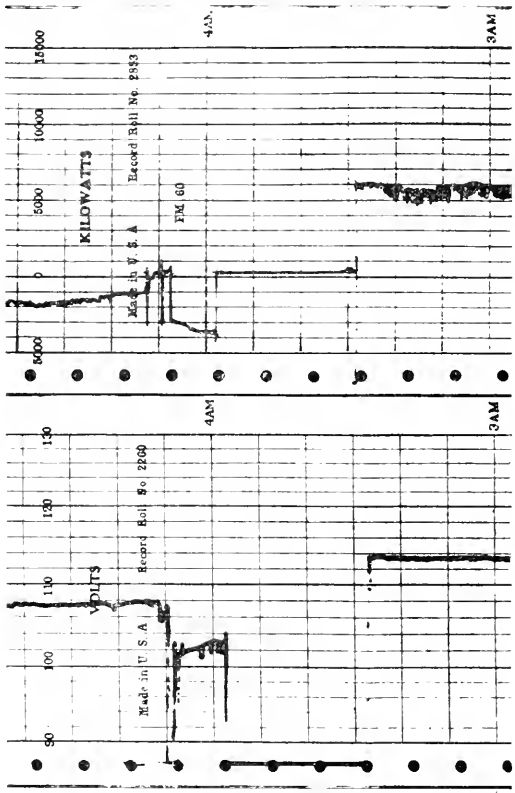
An accident in graph form. Above—Wattmeter chart showing power conditions on No. 1 Edison feeder. The generator stopped supplying power at about 3:28 A. M. The plant was dark until 3:58 A. M., when utility power was admitted for ten minutes, burning out the idle alternator. Below—Bus voltage chart for the same period revealing why the plant's direct current motor-generator sets would not start during the 10-minute interval mentioned above.

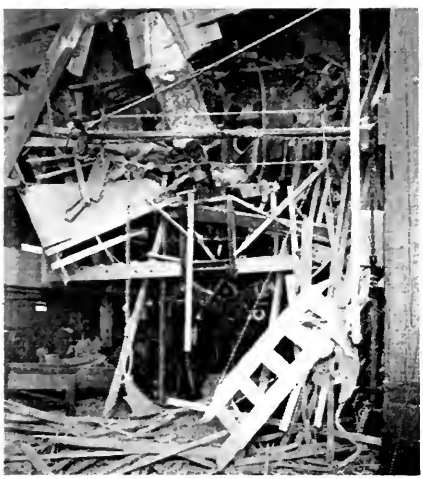
THE steam cylinder of a cotton compress exploded on November 13, 1935, in a Texas warehouse with the results shown in the accompanying illustration. The cylinder was made of cast iron and was 81" in diameter without an upper head.

Cotton compress after explosion of its steam cylinder.

The cause of this accident was undetermined, but it is probable that a crack had weakened the cylinder, which is open at the top and is of massive construction with girthwise reinforcing ribs and a heavy flange at the top. The cylinder broke into four pieces, each of them weighing many hundred pounds.

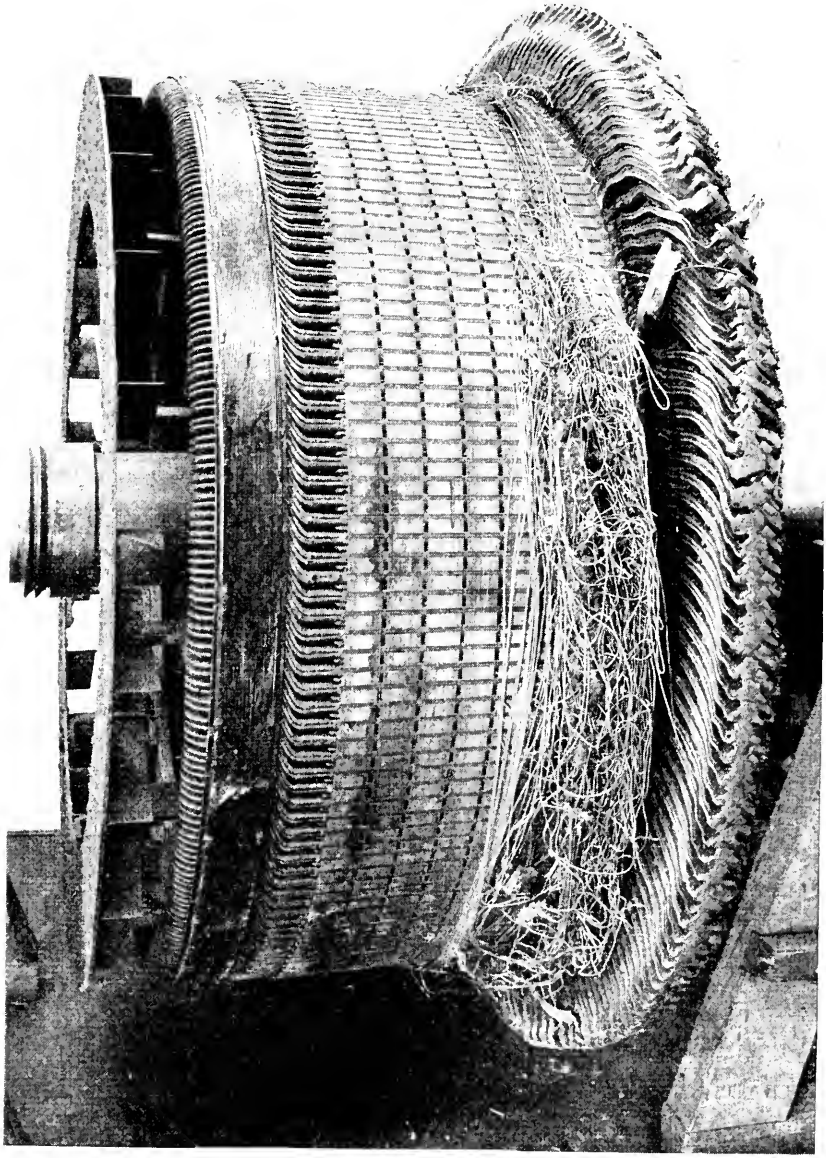
900 Hp Hoist Motor Damaged Because of Overspeed.

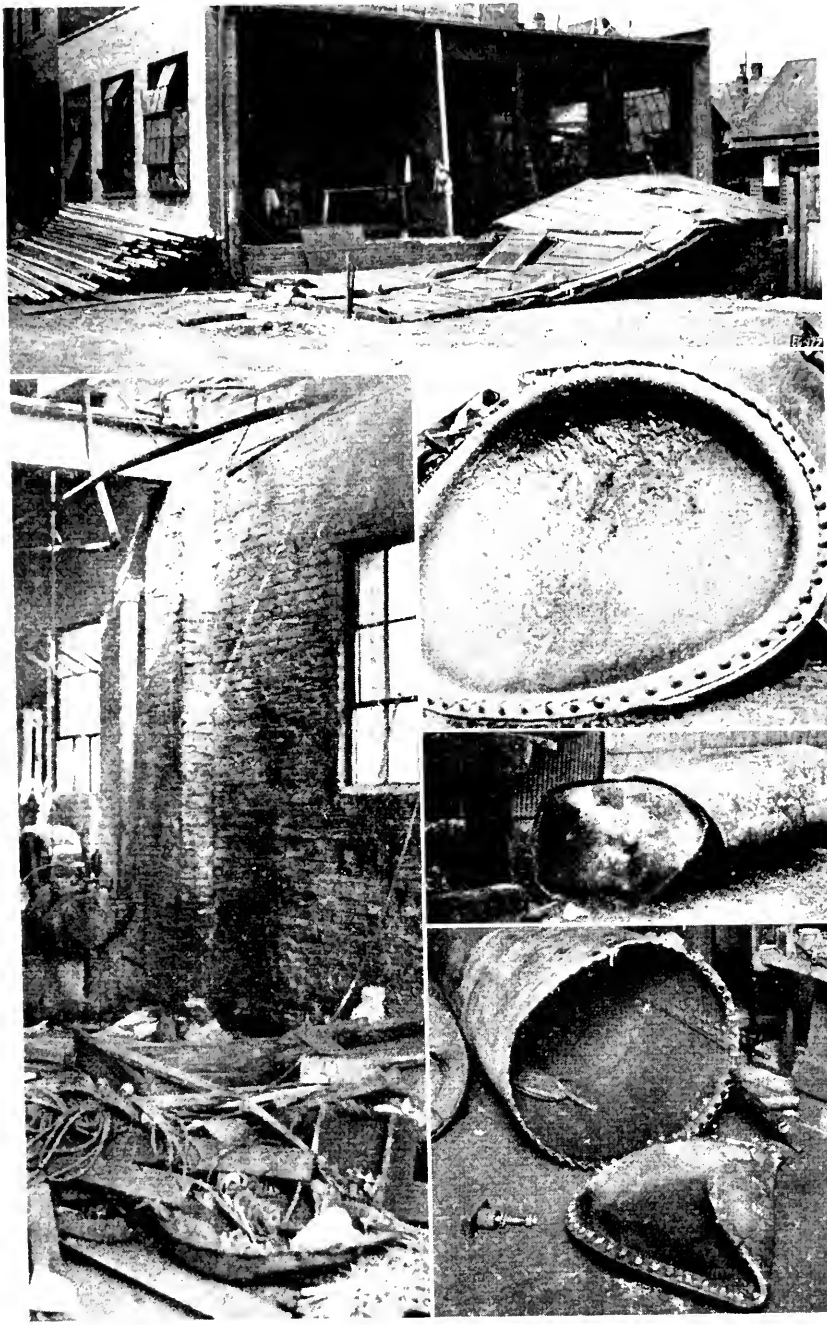
Top—Side of building blown out by the explosion of the tank shown at the lower right. Upper right—Minus head reversed by oil vapor explosion. Center right—Failure caused by corrosion of rivets. Lower left—One man died and two were hurt when an air tank exploded and soared through the roof.

An Ohio scrap-iron baling plant was wrecked by the explosion of an air receiver 3′ 6″ by 7′ with a minus head 3/8″ thick. Again it was the reversal of the minus head because of an oil vapor explosion which tore open the tank. In this case, just prior to the blast, flame was noted issuing from the safety valve. Employees also reported that the safety valve had been operating intermittently and that the discharge pipe from the compressor was red hot. The air compressor was definitely in need of extensive repairs, and as its large oil feeders were filled at least twice a day, it may be assumed that an abnormally large amount of lubricant was used. The head of the tank is shown in the accompanying illustration.

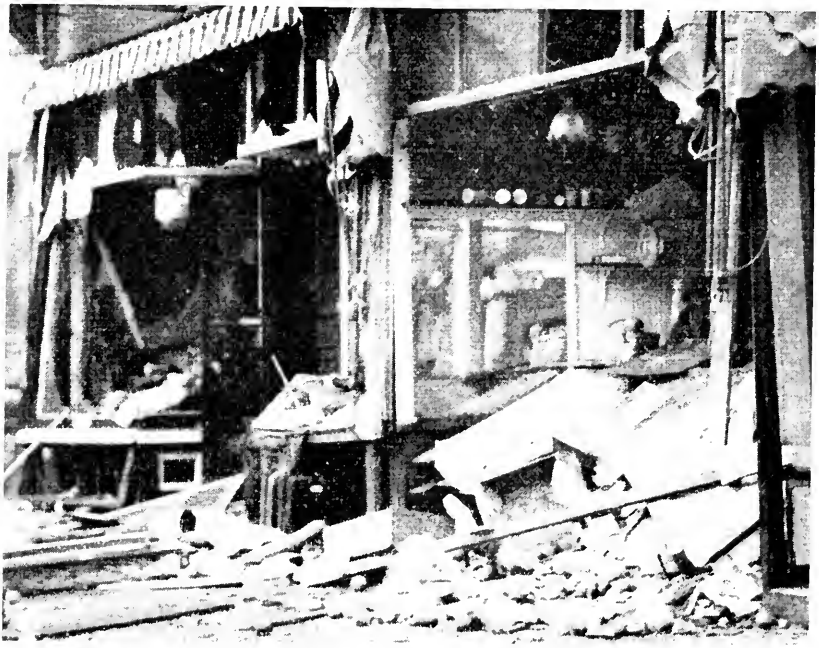
A cast iron boiler explosion on November 18, 1935, injured four persons and wrought damage estimated at $10,000 to these stores.

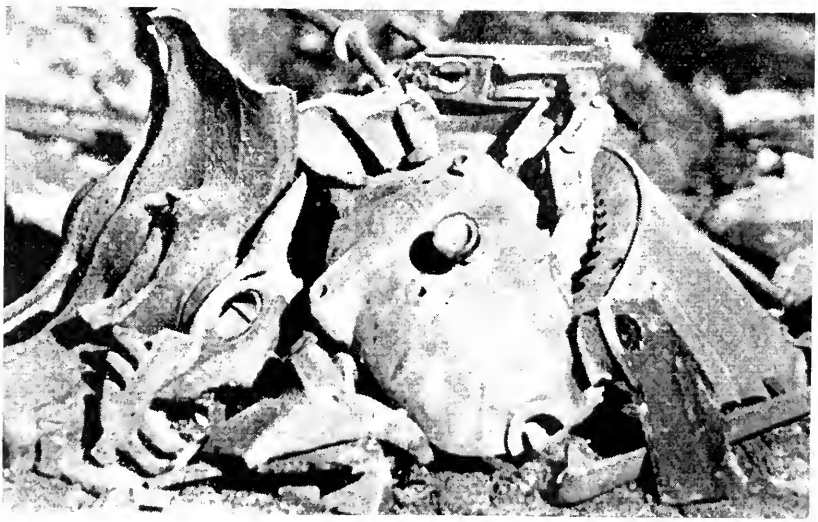
Parts of the boilers which were picked up after the accident. The boiler, which was one year old, was not insured.

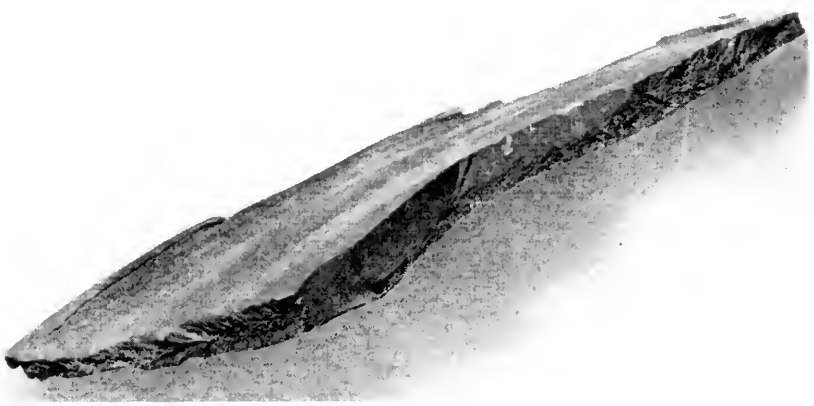
A 3,500 kw impulse turbine driving a generator at a Southern cotton mill was destroyed when the 3rd stage disc exploded because of

Section of turbine disc which exploded because of a fatigue crack.

a progressive crack. Replacement of the machine, which was about 12 years old, involved an estimated cost of more than $100,000. The explosion took place while the emergency governor was being tested. When the machine reached 8 per cent above its operating speed, vibration suddenly increased and the accident occurred. The steam end was wrecked, there was serious damage to the generator because of the distortion of its shaft and the rubbing of the field against the stator, the foundation was cracked in several places, and extensive damage was suffered in the condenser room. As the severed section of the wheel did not go through the steel turbine casing, there was no loss of life or serious injury to the operators, although the jolt knocked a helper off his feet. It was felt that, although the testing of the emergency governor may have hastened the time of the ultimate failure, the accident would have occurred at some later date under ordinary

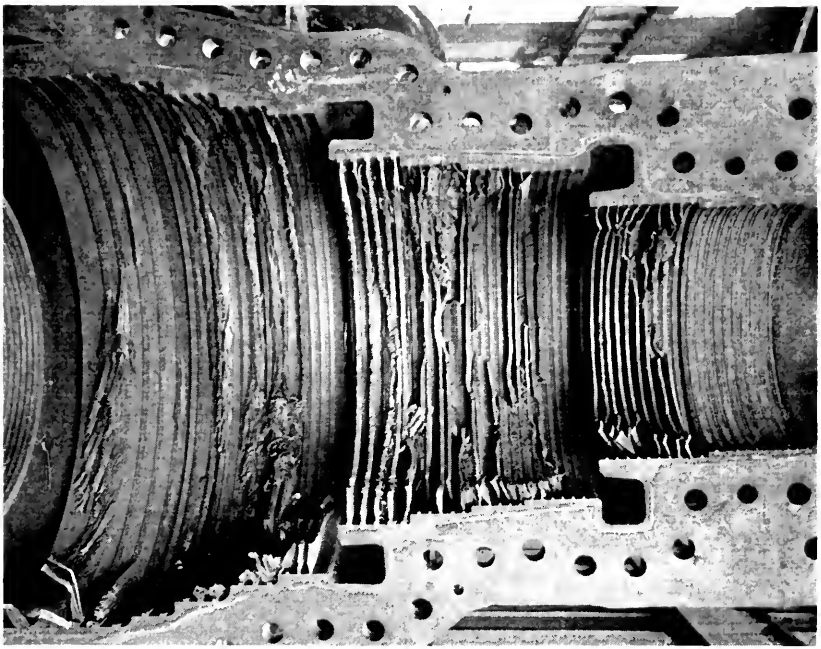
Mashed rows of reaction blading after temperature strains had contracted the casing and rotor unevenly.

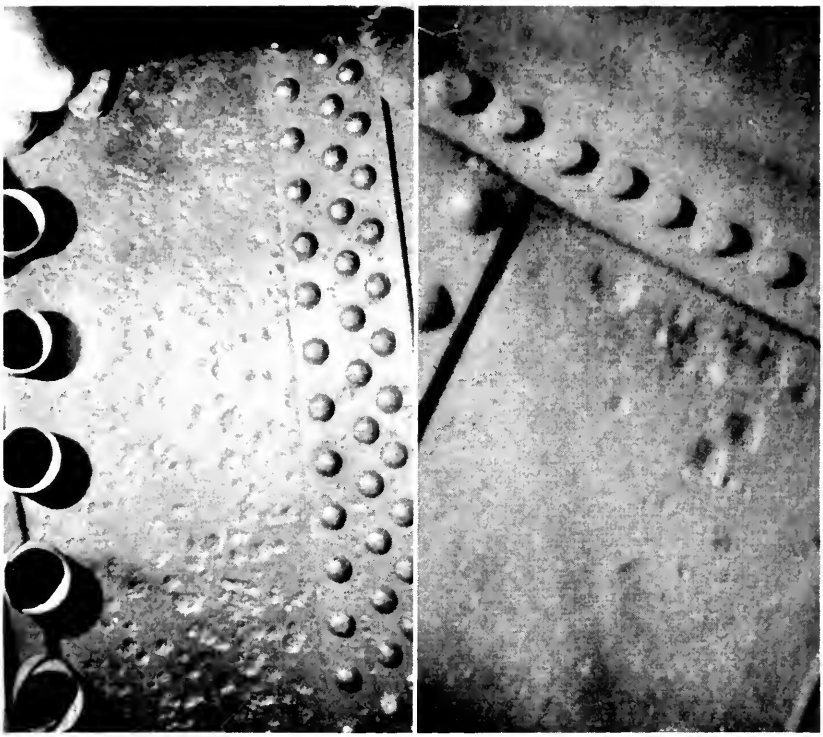
Characteristic pitting in boilers operated intermittently.

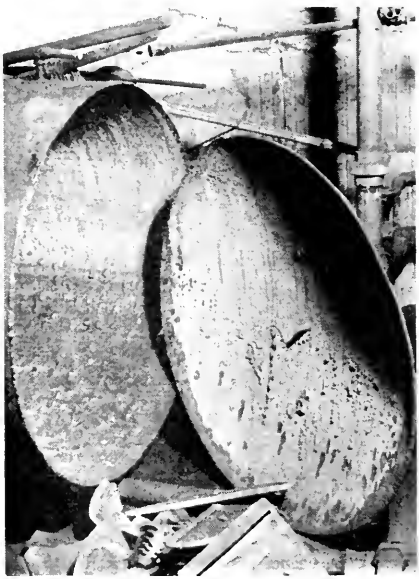
Hydro-Pneumatic Tank Fails Due to Poor Weld

This hydro-pneumatic tank with its saucer-shaped head failed because of a poor weld. The pressure at the time of failure was 35 pounds. The dimensions of the vessel were 14′ by 42″, and both the shell and the heads were of ¼″ thickness.

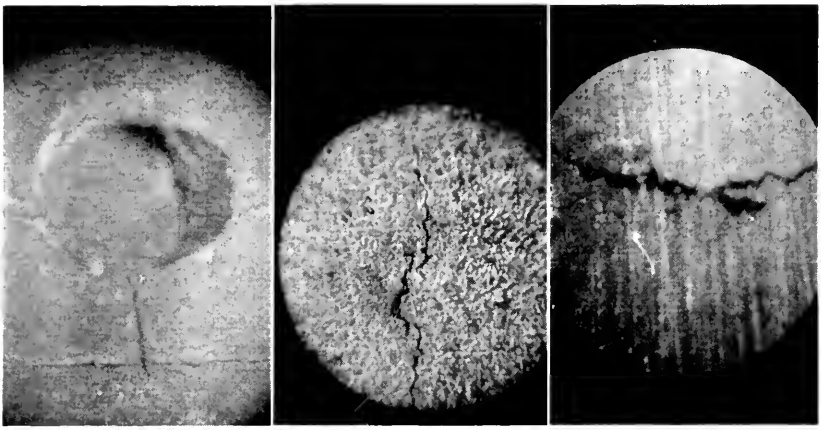
ON inspecting a power boiler at a Mid-West plant, the insurance of which Hartford Steam Boiler was recently asked to take over, the inspector discovered a leaky seam which showed evidence of having been caulked repeatedly in a fruitless effort to make it tight. He noticed, too, that several new rivets had been driven in the seam. Inquiry developed the information that the seam had been giving trouble for some time and that rivet heads had been found broken off

Left—crack which caused the leakage. Center—the crack at the left as it appeared in the rivet hole. Right—characteristic embrittlement cracks with which the plate was affected.

from time to time. As these symptoms pointed to the probable existence of serious distress, the inspector took steps to verify his suspicion. His investigation led to the discovery of a case of plate embrittlement which had progressed to a dangerous degree.

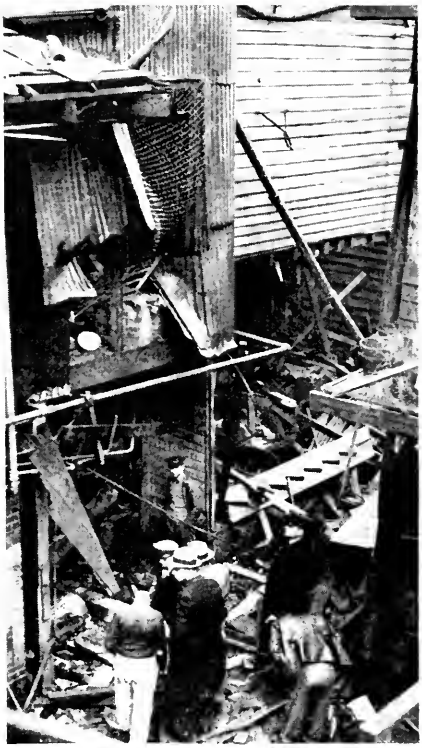
The explosion of a vertical tubular boiler 30″ x 7′ at a Southern ice cream plant damaged three buildings, one of which is shown in the accompanying photograph. There was no evidence of over-heating, and the accident was attributed to operation of the boiler at a pressure in excess of that for which it was built. The boiler traveled about 10 feet after the furnace sheet failed.

Damage following explosion of vertical tubular boiler.

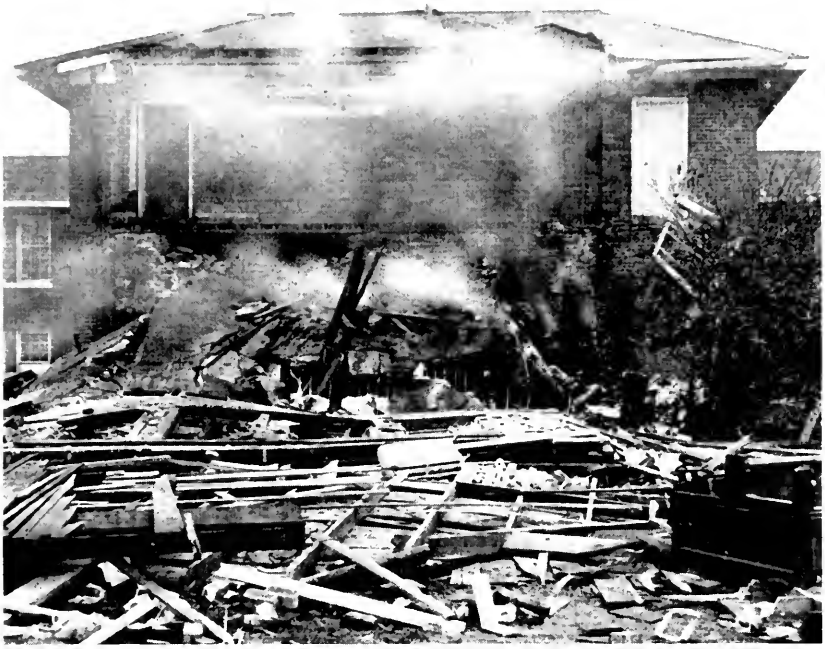
A YOUNG music teacher was killed when a hot water supply tank exploded in the boiler room of the consolidated school at Horn Lake, Mississippi, on the morning of February 17. Fortunately a recess saved the children. The sixth grade had left the music room, situated over the boiler room, barely five minutes before the explosion, and the school quartet was due there for rehearsal in another

Wreckage of music room and boiler room after explosion.

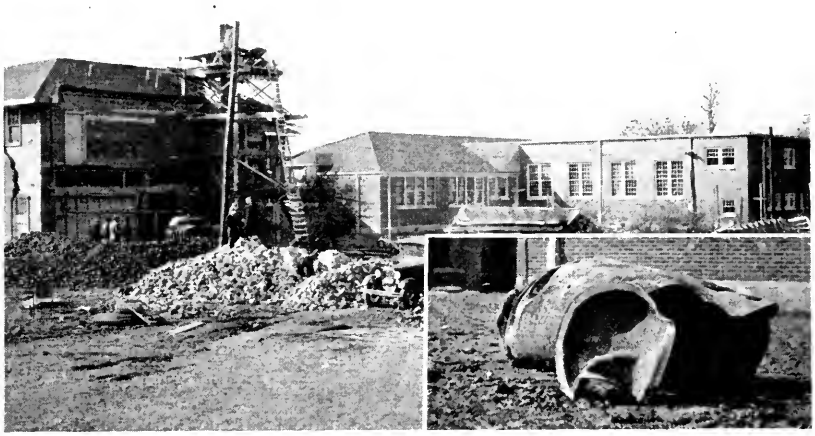
Water for it was heated in pipe coils in the fire box of one of two cast iron sectional steam heating boilers. Inquiry subsequent to the accident revealed that there had been a check valve in the cold water supply to the tank and that there had been no relief valve on the sys-

Repairing damage after explosion. Observe the 3′ hole (boarded up) in brick wall of gymnasium, extreme right of picture by small double windows. Inset—Remains of tank showing reversed minus head.

tem. As it was a cold day, both boilers were in operation, but due to stoppage of drains in the shower room, no hot water was being used. Pressure built up in the tank until the minus head reversed and tore away, striking one of the boilers. The rest of the tank broke its way through the six-inch reinforced concrete floor of the music room, ripped down one of the brick side walls and hurtled across 150 feet of lawn to the gymnasium where it knocked a large hole in the wall, showering bricks and debris on boys who were playing basketball there.

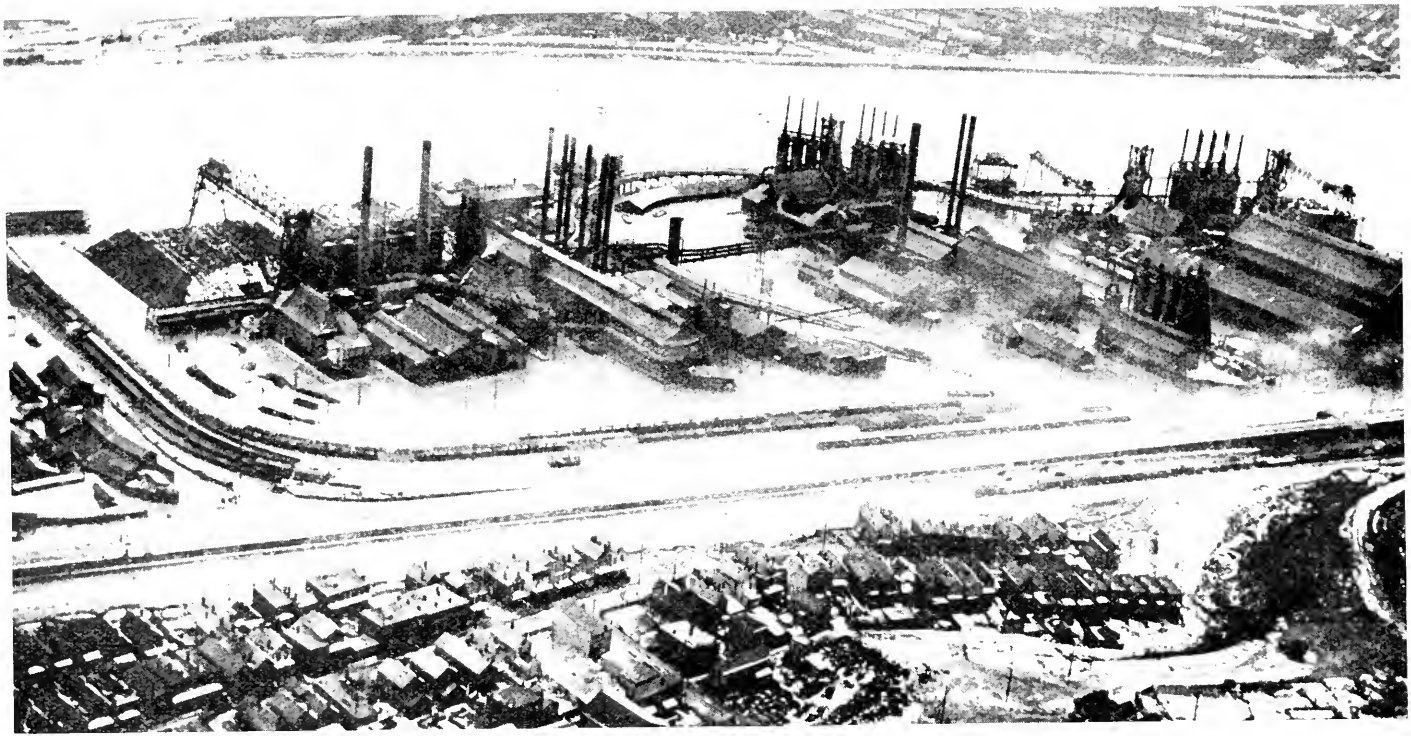
Part of the flooded area in the Pittsburgh section. Hundreds of electrical machines were inundated in these steel mills and in many other industrial plants both in this and in other areas.

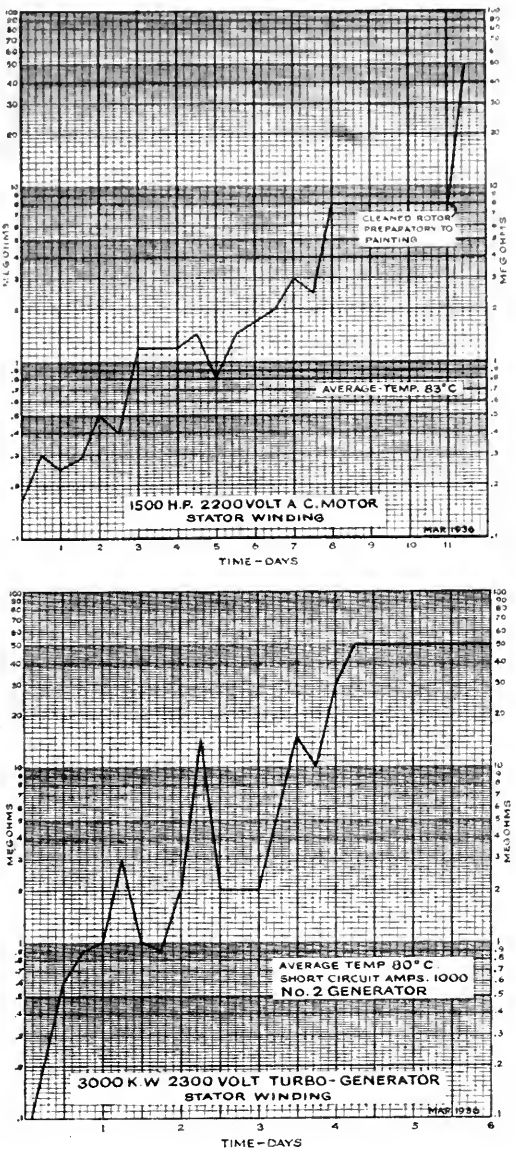
Representative graphs from log readings taken while drying out rotating electrical machines.

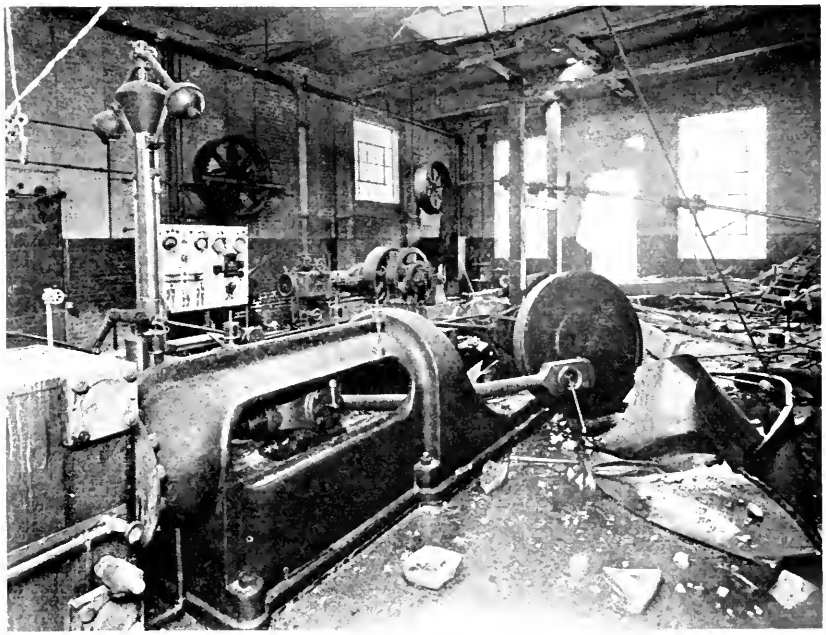
Engine room after the flywheel exploded and wrecked the engine.

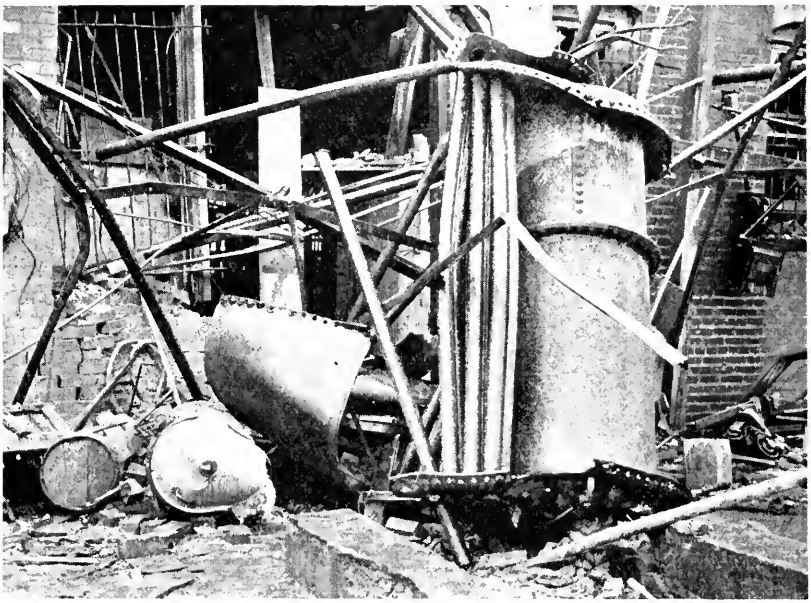
A check-up of the welding in a patch that failed might have prevented this $25,000 boiler accident.

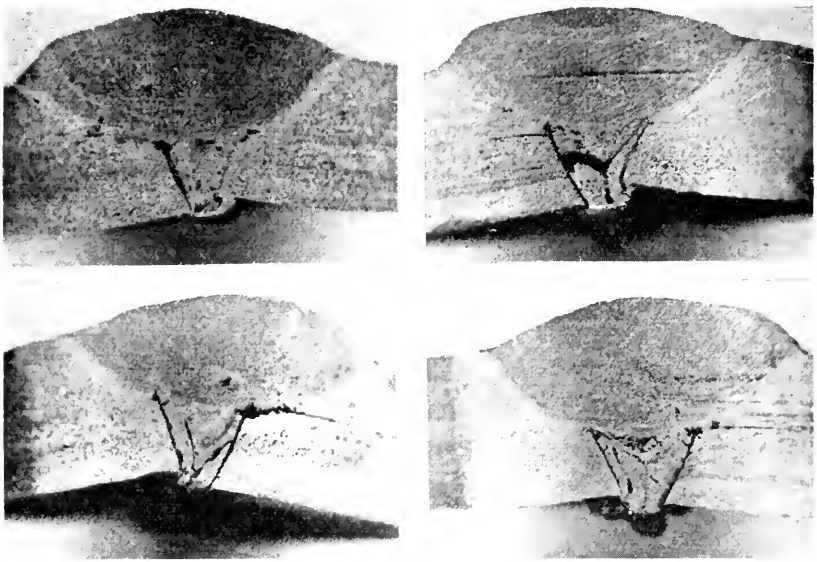
Samples of characteristic defects in welded seams.

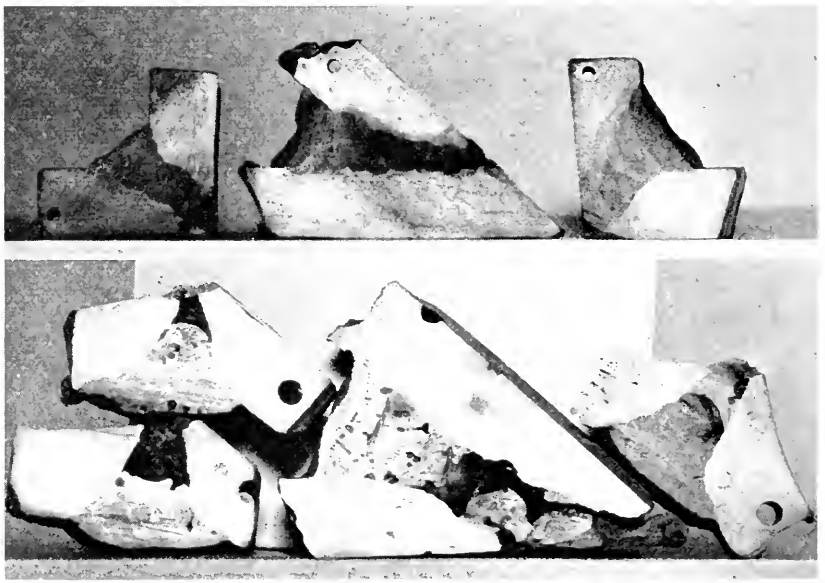
Good and bad fusion in pipe joints.

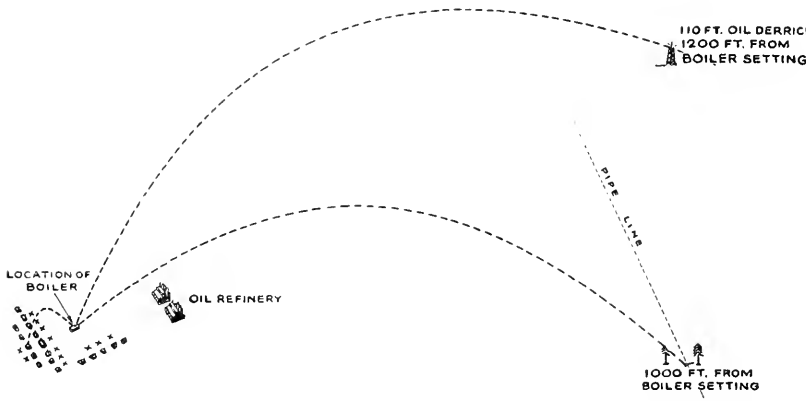
EIGHT persons were injured and property over a wide area (as shown in the sketch) was damaged when a locomotive type boiler exploded at a Texas oil well location in April. The accident, clearly a case of over-pressure, tore the boiler into several pieces and resulted in damage to property as far distant as 1200 feet from the boiler setting.

Path taken by parts of boiler which exploded at a Texas oil well location. The boiler was used to furnish power for pumping oil through various pipe lines.

aged. One piece of metal passed over a two-story hotel and crashed into a hut behind it, the metal falling in such a way that a negro woman was pinned in bed, but was not seriously injured. Other pieces hurtled over the refinery building, one whole course passing through the top of a large pine tree 1000 feet distant, cutting a 6″ oil pipe buried about 2 feet underground, and making a deep gash in a second tree. Another piece of the boiler broke off the top of a 110′ oil derrick which was 1200 feet from the boiler.

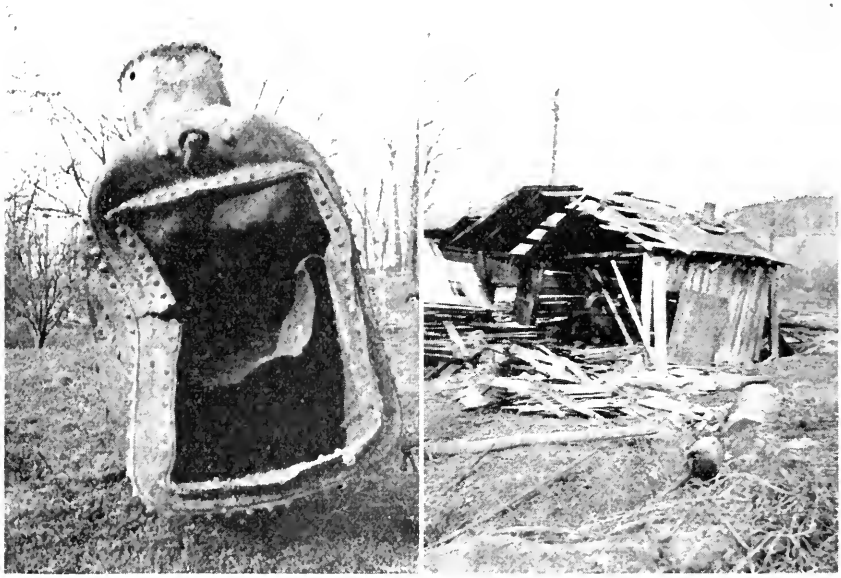
Left:—Boiler after 300 ft. journey. Right:—The shattered engine house where the eight persons who were killed or injured had gathered.

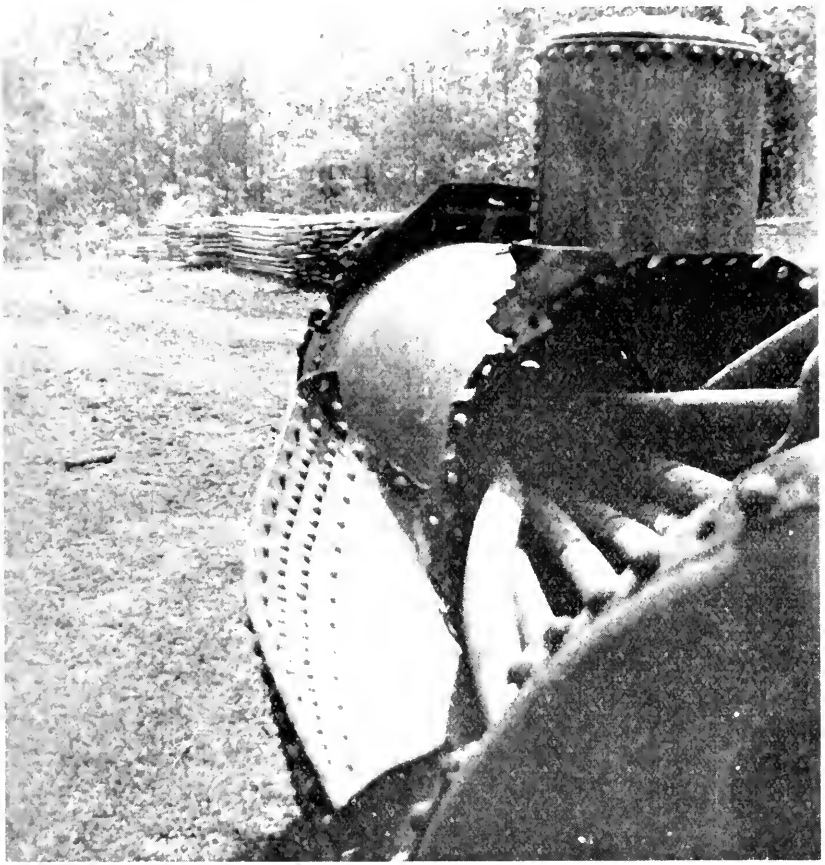
After the boiler had traveled 60 ft.

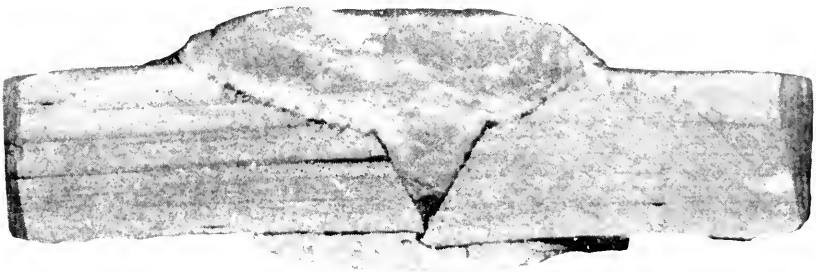
Figure 5

Figure 5. Illustration of an extreme case of lack of fusion in the lower half of the welding groove, slag on the fusion line and almost entire lack of fusion of reinforcement on the underside.

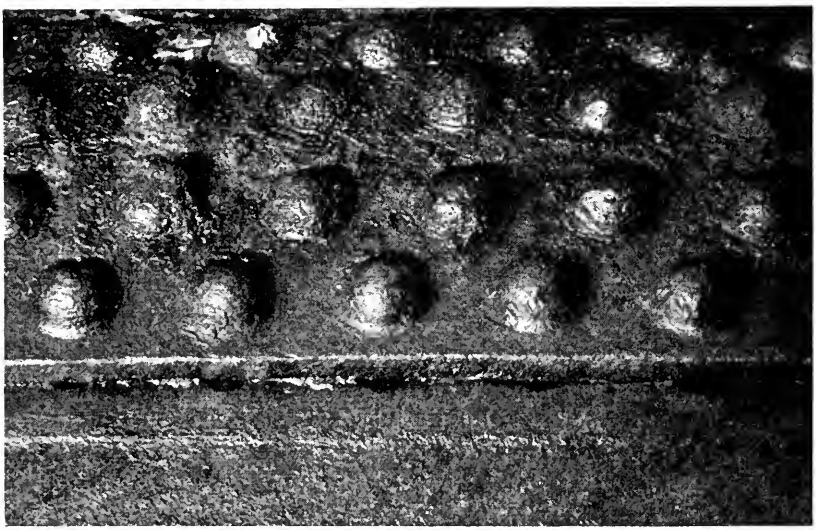
Figure 1—Seam which pulled apart for 6 feet after embrittlement had developed to a serious extent.

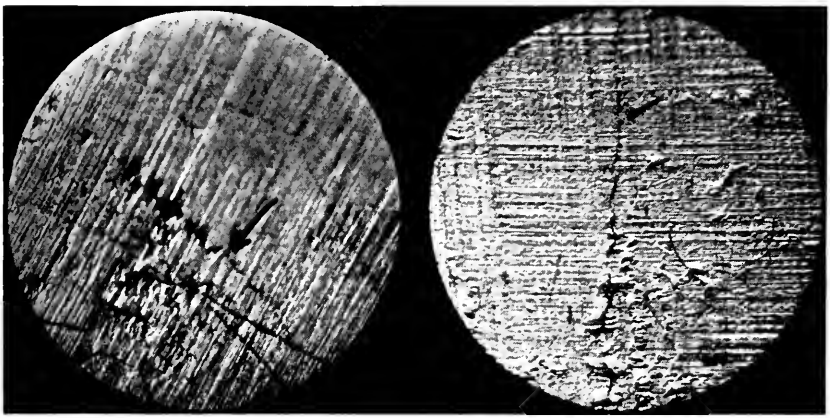
Figure 2—Characteristic embrittlement in another boiler of the same battery as the affected vessel.

the rivet holes in the top row. These cracks were characteristic of embrittlement in its final stages.

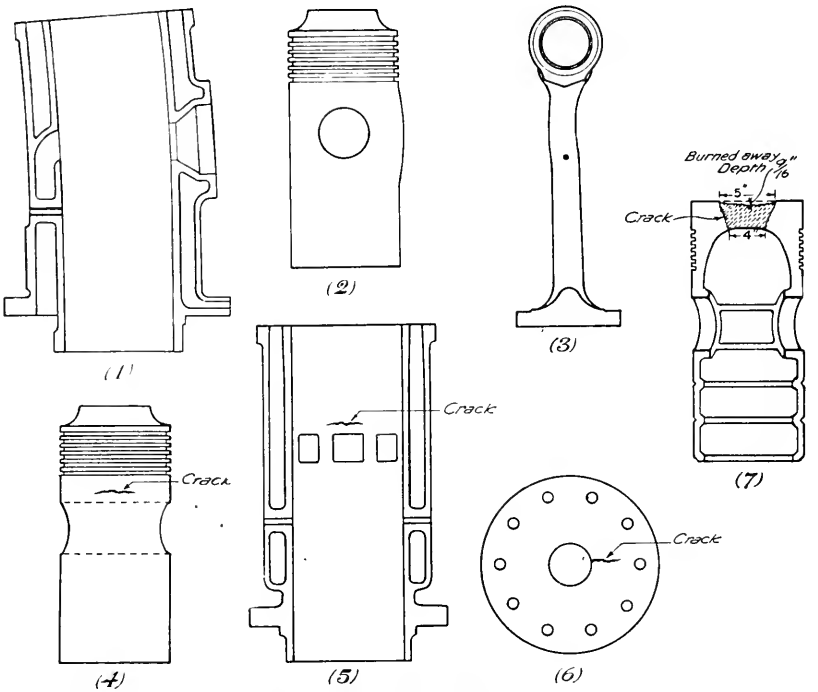
Six evidences of over-heating in a single Diesel cylinder—(1) Distortion of the cylinder because of "growth"; (2) "Growth" of piston; (3) Bend in connecting rod; (4) Crack in piston; (5) Crack in cylinder; (6) Crack in cylinder head; (7) Another evidence of over-heating in another piston. The head was burned to a depth of 9/16" and a crack had extended through the top of the piston.

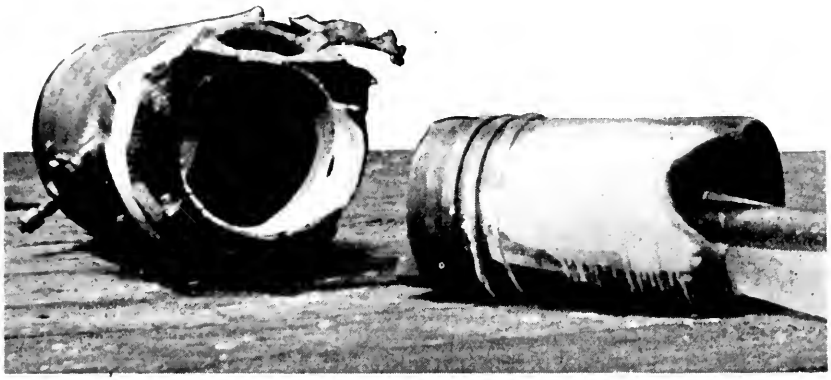
Figure 8—Piston and part of cylinder which broke off due to overheating. The machine was a small two-cylinder engine.

effect of the silicon. It may well be asked why this action does not take place on the surface of the piston. The theoretical explanation of this is that the separated carbon is re-fused into the solid solution by the higher temperatures at the top of the cylinder and further, that the oil which comes in contact with the piston top saturates it and acts as a protective influence. At any rate the distortions because of "growth" in Diesel engines occur as is shown in Figures (1) and (2). From these it will be seen that the "growth" itself is only part of the difficulty, as its presence leads to a distortion of the entire cylinder, which distortion is contributory to the eventual seizing of the piston.

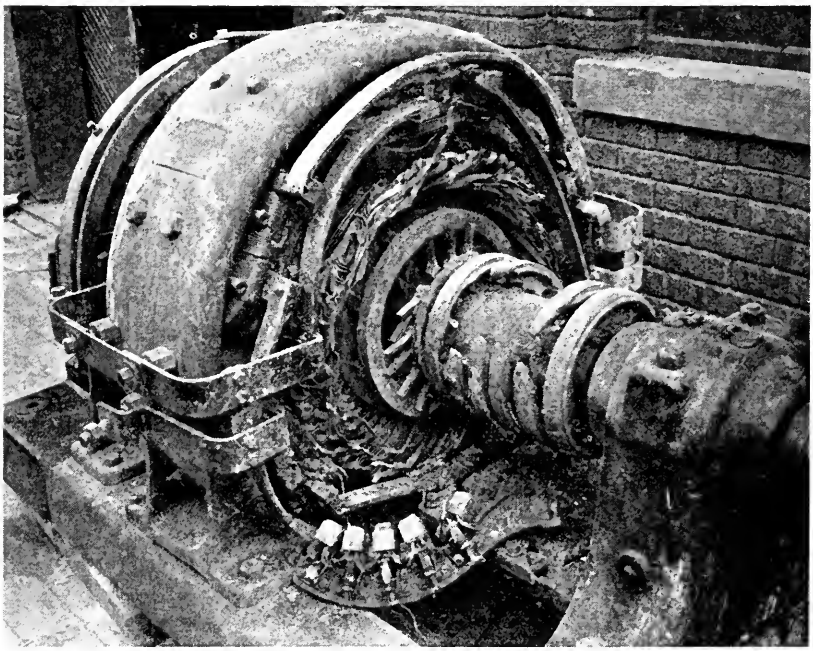
Rotary converter damaged by short circuit and fire.

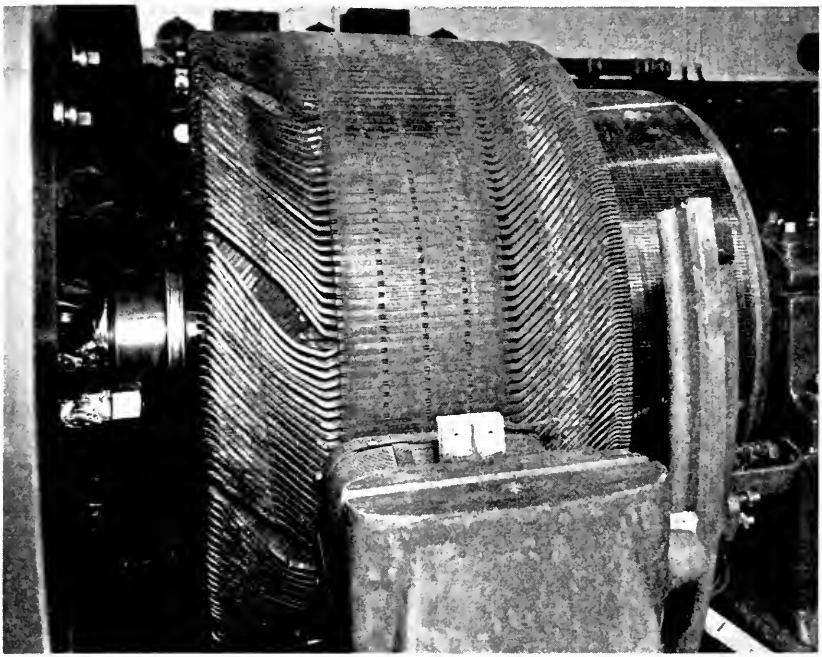
Distortion of coils on a 500 kw direct current generator caused by a surge when the operator threw the wrong switch connecting the idle machine to the station bus.
